Coliseum Requires Specialized Containment During Reroofing Project

CASE STUDY 8

Ector County Coliseum
Texas Roof Management

63,000 sq. ft. of
SmartSeam[®]
Suspended Cover
and netting

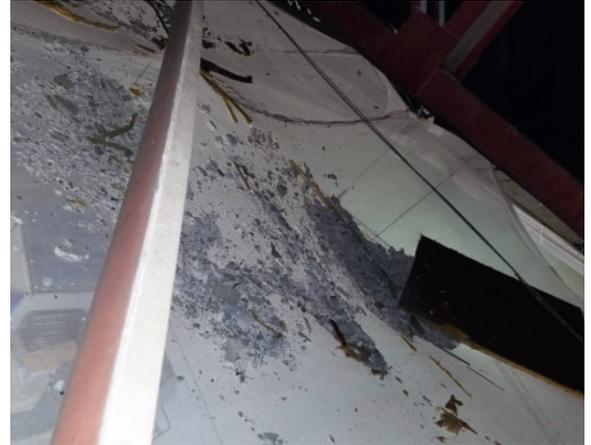
View of debris captured in the netting and suspended cover solution above the Coliseum seating area.

In order to capture the larger chunks of the roofing panel, TuffWrap installed netting as a first layer of defense. In situations where there is the potential for heavy debris to fall, netting provides additional strength to the overall solution.

After the netting was put into place, suspended cover was installed. SmartSeam[®] was chosen because it does not impede the sprinkler system.

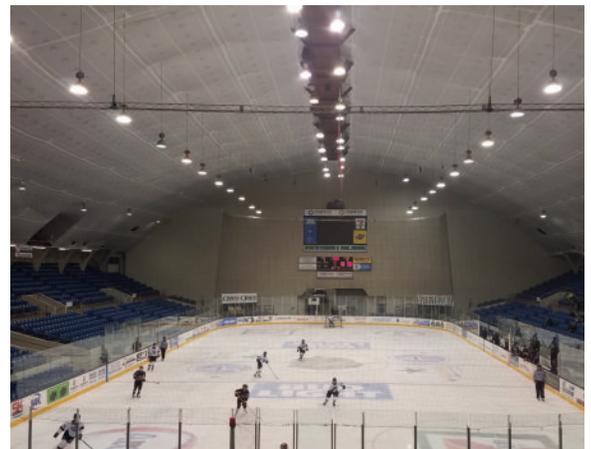
Hockey team plays under installed suspended cover and netting solution.
